Test Report

Project NO.	: <u>21MD03-001</u>
Edit Date	: <u>Mar.05</u> . 2021
Applicant	: Sales Dep. MAGIX(KUNSHAN)
Address	: 99 ChangShun Road,Zhangpu Town
	Kunshan City China.
Product	: <u>Handlebar+Stem</u>
Model No.	: <u>CHB-A6002-2</u> W:600 mm
	EQS-STD102Z-2 E:80mm L:250
Test Reference	: EN15194:2017 (E)
Abstract of Result : Details as in test report.

Project NO: 21MD03-001

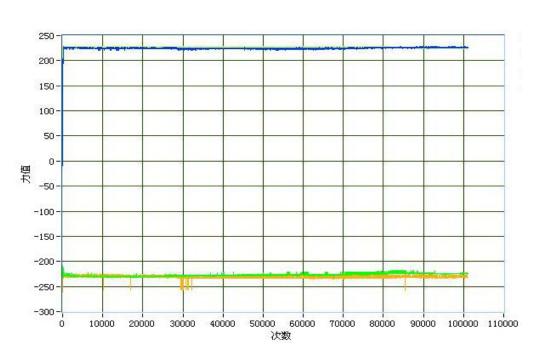
Out phase test

8.试验次数 Setting cycle: 100,100 9 力量 Force: ± 220 N

NO1: 100,100 cycle no visible cracks.

3. Dynamic test: out phase, 3HZ, F=±220N, NO1=100,100 cycle, NO2=100,101 cycle;

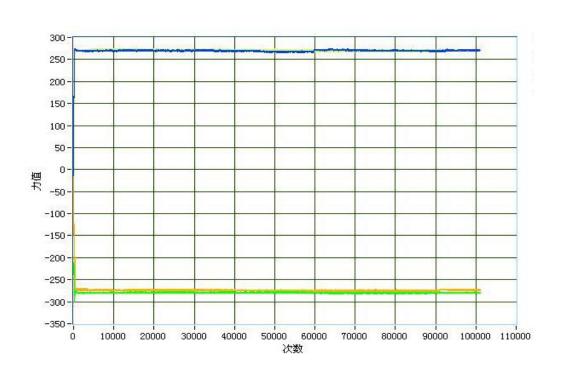
In phase test

8.试验次数 Setting cycle: 100,101 9 力量 Force: ± 280 N

NO1: 100,100 cycle no visible cracks.

in phase ,3HZ,F=±280N, NO1=100,100 cycle, NO2=100,101cycle.
