Test Report

Project NO. : 21MD09-014

Product : Handlebar+Stem

Test Reference : EN15194:2017 (E)

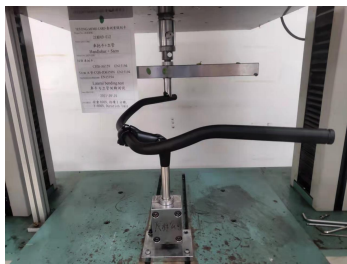
4. Appendix: Static test picture

3. Static test: acting-force:800N. Acting force place:50mm away from handle bar end lasting time:1 min

4. Pass : permanent deformation < 15mm, test based on said no crack or fracture incurred fur stem

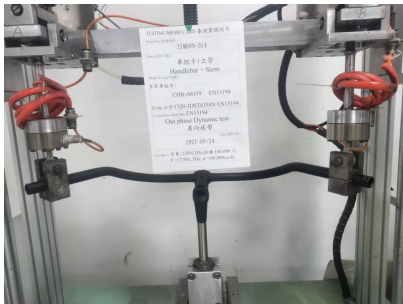
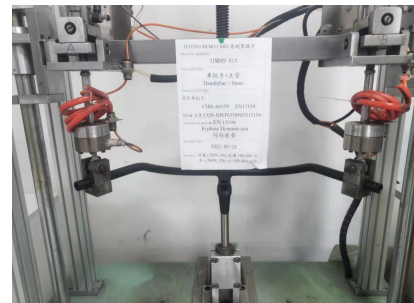
6.Test dynamically:

3. Dynamic test: out phase, 3HZ, $F=\pm 220N$, NO1=100,100 cycle, NO2=100,101 cycle;
in phase ,3HZ, $F=\pm 280N$, NO1=100,100 cycle, NO2=100,101cycle.

4. Pass: During the testing no visible break or crack occur.
