# TESTING REPORT

Mode	Seat post	Testing Qty	1pcs	Material	AL6061
Model No.	MSP-D604 (M10)	Φ 31.6*400mm	Test Reference	ISO 4210	
Mark	Testing Standard			Testing Result	
Dynamic Test ISO 4210:2014-9 4.5.2	<p>1.The seat post being introduced at a minimal depth in a fitting and being rigidly tightened.</p> <p>2.The angle between the horizon and choking appliance to elevation 10°</p> <p>3.The seat post is alternatively under pressure during 100000cycle times.</p> <p>4.The frequency must not be over 10HZ,F=1200N.</p> <p>5.During the test no visible break or crack Occur.</p>

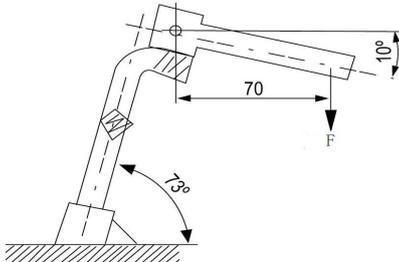
<p>NO1: 3HZ 101,000times, no visible break or crack Occur.</p>	
Remark:.		Result		<input type="checkbox"/> NG <input checked="" type="checkbox"/> PASS	
1. Test Reference: ISO 4210-9 2014		Checked by		Tester
